# INSPECTION OF THE TOP ENDS OF REFORMER TUBES

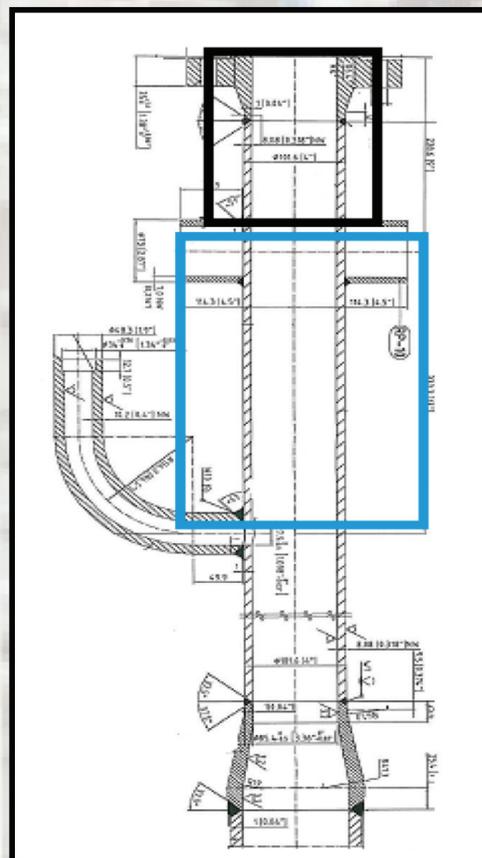
Figure 1: Top Fired / Down Flow

In these reformer designs, the burners are top fired with a down flow process. The inlet gas is injected through a pigtail into the tube above the furnace radiant box in the penthouse. The unheated tube top section is made of wrought material with metallurgies ranging from low-chrome alloy steel (1.25 Cr - 0.5 Mo) to stainless steel 304H, 347H, or similar materials while the heated length within the furnace is a centrifugally cast material mostly 25Cr/35Ni/Nb or with Micro-alloy additions. See Figure 1.

A number of tube top designs include the use of a side entry pigtail connection and an insulation plug on the blind flange of the tube top. During transient and cold weather conditions, the temperature of the tube top flange can drop below the process gas dew point resulting in condensation in the area shown in “black”. The process gas dew point is typically in a range of around 300-400 °F.

The condensed liquid can then drip down into the area marked in “blue” where it can contact the inside of the tube top causing re-vaporization of the liquid and localized rapid cooling of the tube at that location. Continual dripping of liquid and vaporization of the liquid produces in a cyclic variation in temperature resulting in a damage mechanism called “thermal fatigue”. The stainless steel tube top designs are most susceptible to thermal fatigue damage due to its higher expansion coefficient compared with low-chrome alloys. The higher expansion coefficient of stainless steel materials produces greater thermal stress with localized temperature cycling.

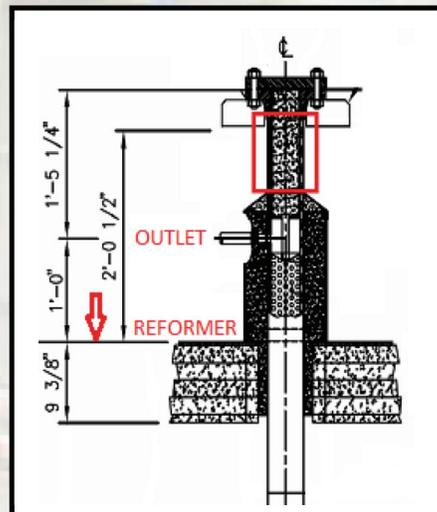
Figure 2: Bottom Fired / Up Flow

In these reformer designs, the reformer is bottom fired with an up-flow process. The inlet gas is injected from the bottom of the tube through an inlet pigtail and the reformed gas comes out from the top of the tube through an outlet pigtail. The outlet pigtail is located on the portion of the tube outside of the heated length on an uncovered roof open to the atmosphere. The tube material is made of the same material as the heated length which is centrifugally cast length which is a centrifugally cast material mostly 25Cr/35Ni/Nb or with Micro-alloy additions. In this scenario, the process gas can also reach its dew point around 300-400 °F and cause “condensation”. See Figure 2.

However, the reasons for this are different from the previous case because the gas on the outlet side is much hotter than the inlet side. In this case, the “condensation” of the process gas inside the tube is caused by greater exposure to weather conditions due to the uncovered roof and insulation issues near the top ends. This is likely in areas where winters are extremely cold and areas where rain is predominant throughout the year.

The area susceptible is marked in “red” as the insulation is often not extended up to just below the flange bolts. This insulation would prevent the low temperature conditions and rain water ingress which can affect the internal conditions of the process gas inside the tube.

The cyclic stresses brought on by these variations in temperature result in the same damage mechanism as for Case I, that is, “thermal fatigue”. In both Case I and Case II, the defects manifest themselves in the form of circumferential cracks or pinhole cracks that initiate from the ID and propagate towards the OD resulting in a leak.
